Manhole Inspection Summary

Manhole # S11S__023MH

Insp Date: **4/4/08 11:40 AM**

Location Address: **3133 Wilkens Ave**

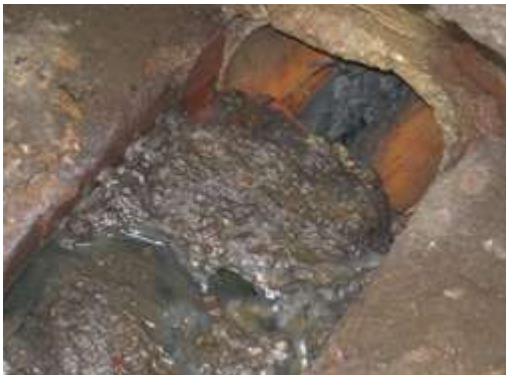
Misc

Comments **Channel blocked with debris: no flow**

Debris in channel

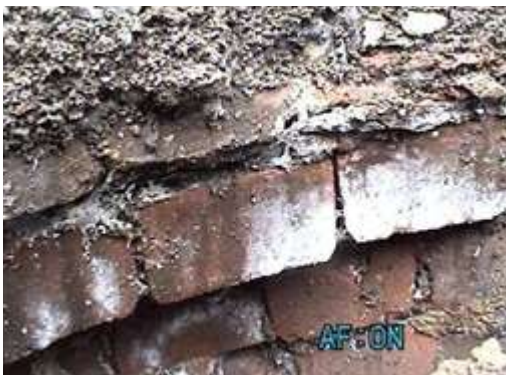
Defect 3

Infiltration: ☐ None ☐ Joint ☐ Cracks ☐ Mortar ☐ Roots ☒ **Wall**

loose mortar and bricks/infiltration at chimney

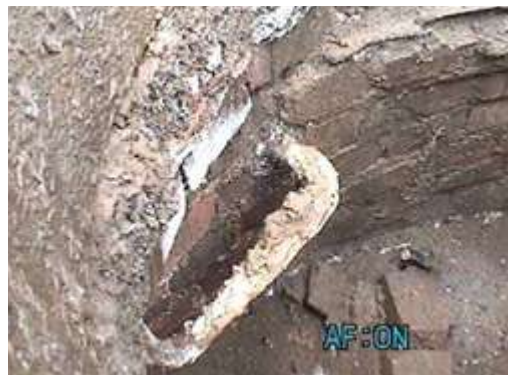
Defect 2

Steps Count: **3** Missing: **0** ☒ **Corroded**

Corroded steps

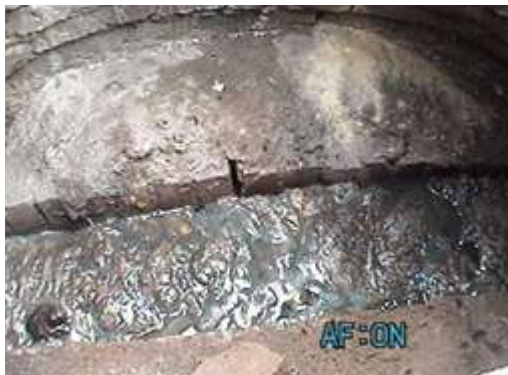
Defect 1

Condition: ☐ Sound ☐ Cracked ☐ Root Intrusion ☐ Deteriorated ☐ Leaks ☒ **Debris**

Debris in channel & bench
